2017-05-03_13-42-47-LE-Report-Leak Survey @ SONOTEC

2017-05-03

Folder	Leak Survey @ SONOTEC
Number of Leaks	6 (6 rated)
First measurement	2016-11-18 16:09:38
Last Measurement	2016-11-18 16:22:32
Total leak flow	40.4 l/min
To repair	6
Repaired	2

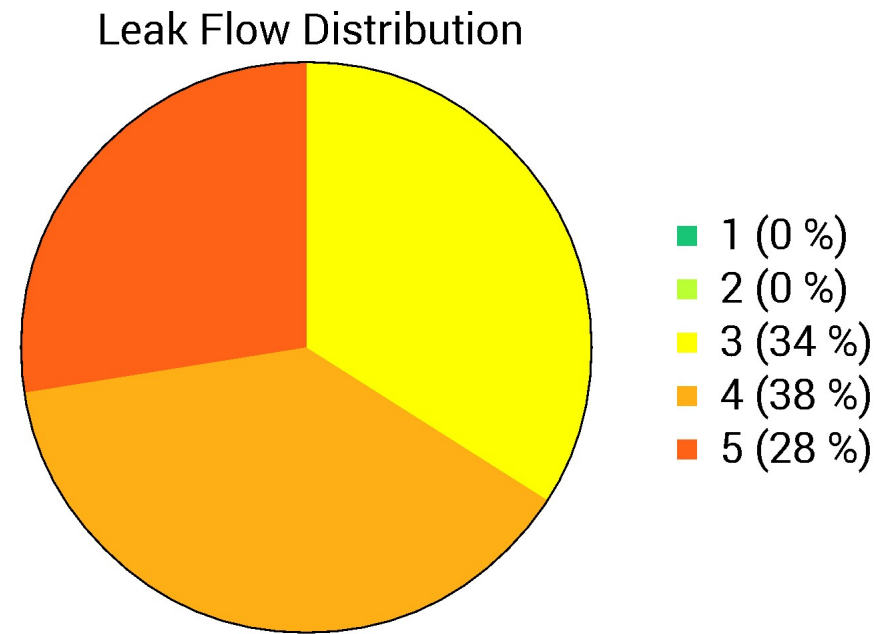
Rating	Id	Flow (l/min)	Level (dB)	Pressure (bar)	Building	Area	Facility	Component	Gas	Priority	To repair	Repaired	Repairer	Repair Date
5	10047-001	11.1	79	8.1	house 4	compressor room	oil filter	sealing	Air	high	yes	no		
	Description: hemp sealing at screw connection										repair note::			
IMG_0001.JPG		IMG_0002.JPG
